Orbital Transfer Rocket Engine Technology Program

Contract NAS3-23773
Task B.5

Soft Wear Ring Seal Technology

FINAL REPORT

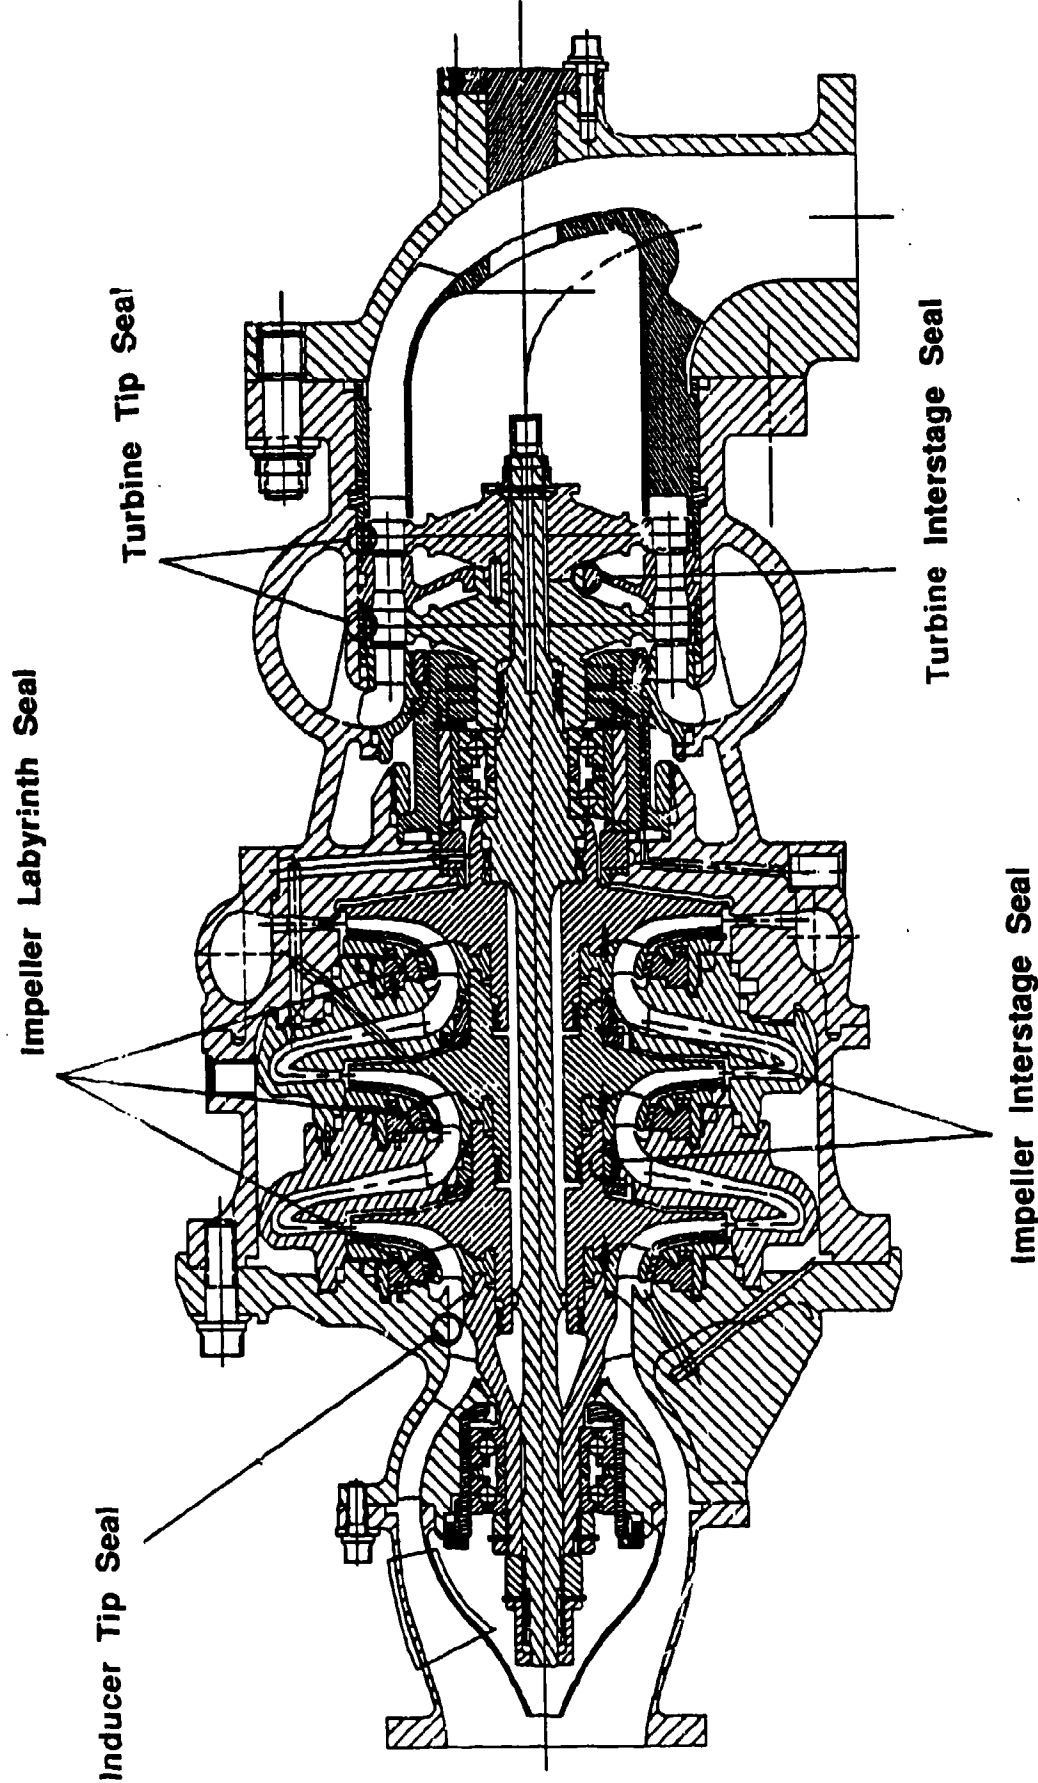
Figure 1

MK49-F Liquid Hydrogen Turbopump with Potential Soft Seal Applications

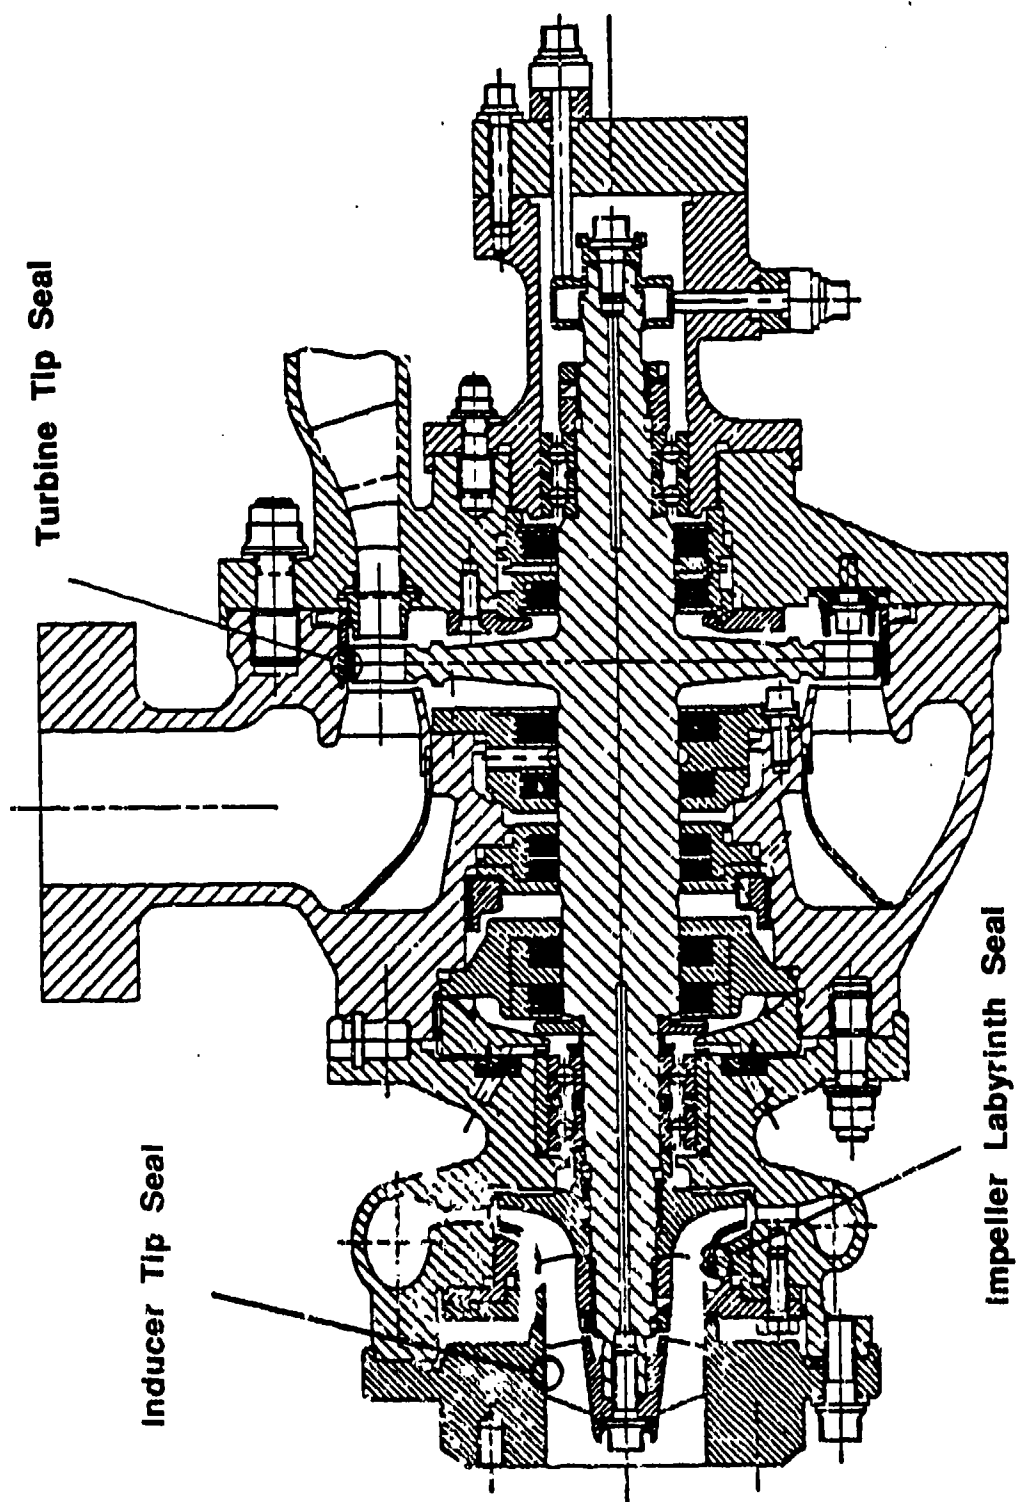
Figure 2

MK49-O Liquid Oxygen Turbopump with Potential Soft Seal Applications

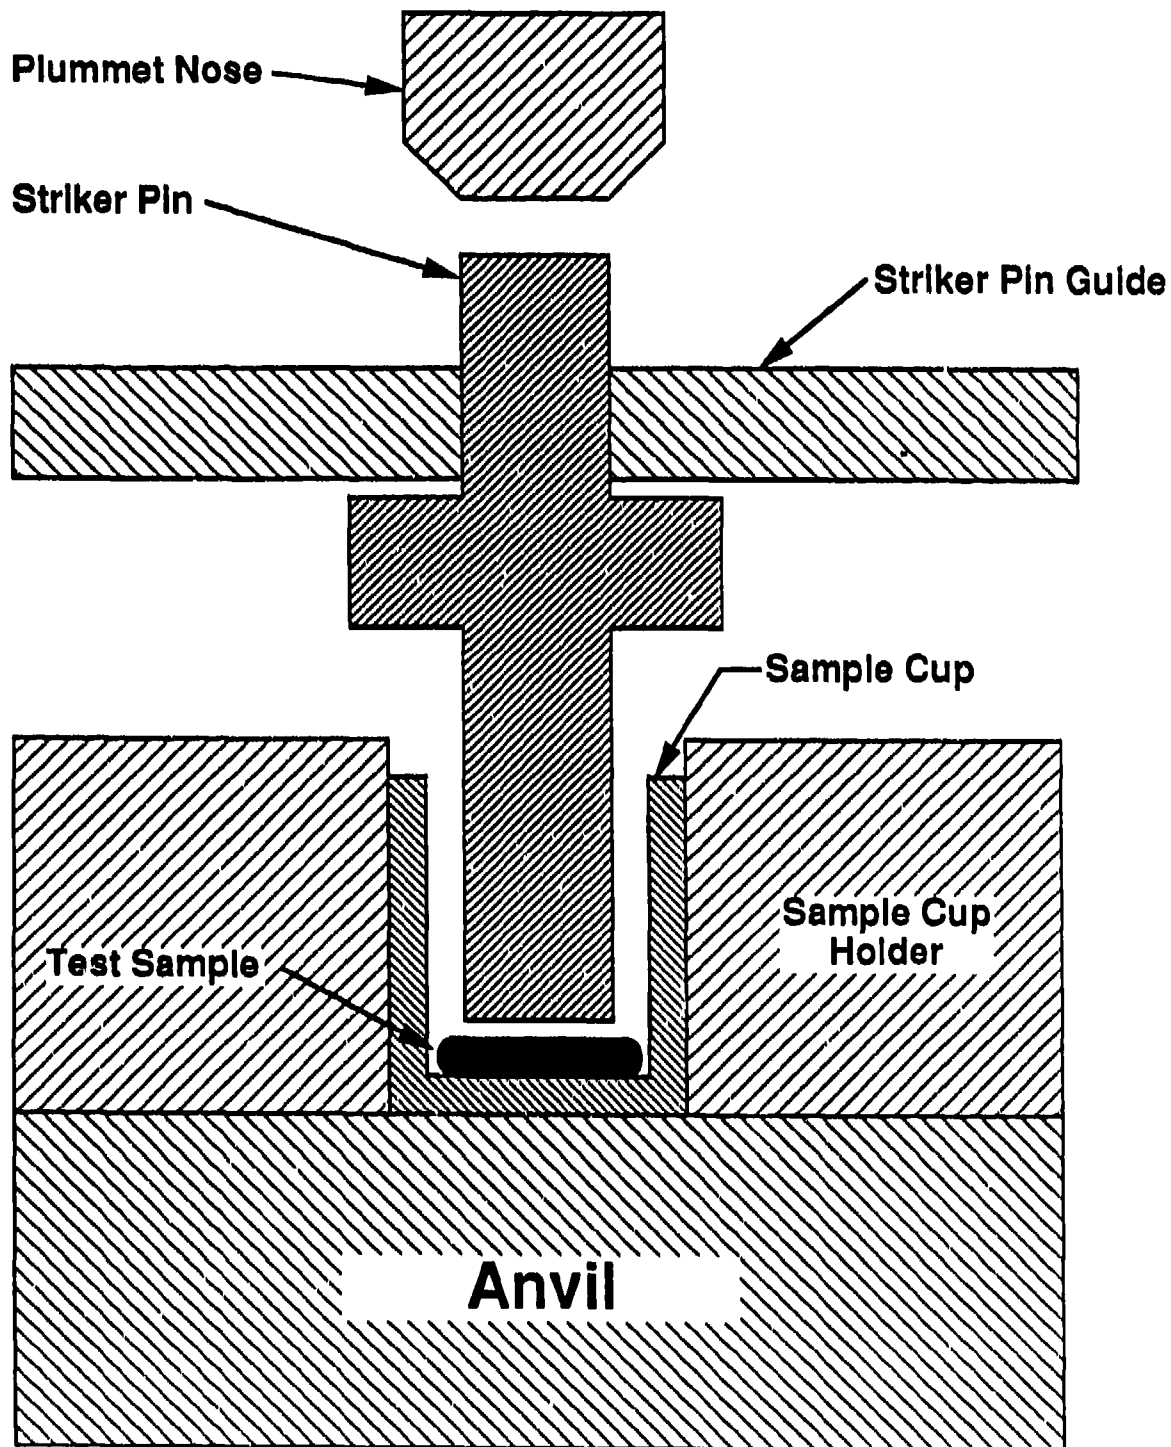
Figure 7

LOX IMPACT TEST CHAMBER

The LOX impact tester, located at the Rocketdyne facility, consisted of three major components: impact tower, pneumatic enclosure, and control console. The impact tower and pneumatic enclosure were housed in a remote test cell, as shown in Figure 8, while the console was located in the control center. The oxygen test system schematic showing the propellant feed and pressurization system is shown in Figure 9.

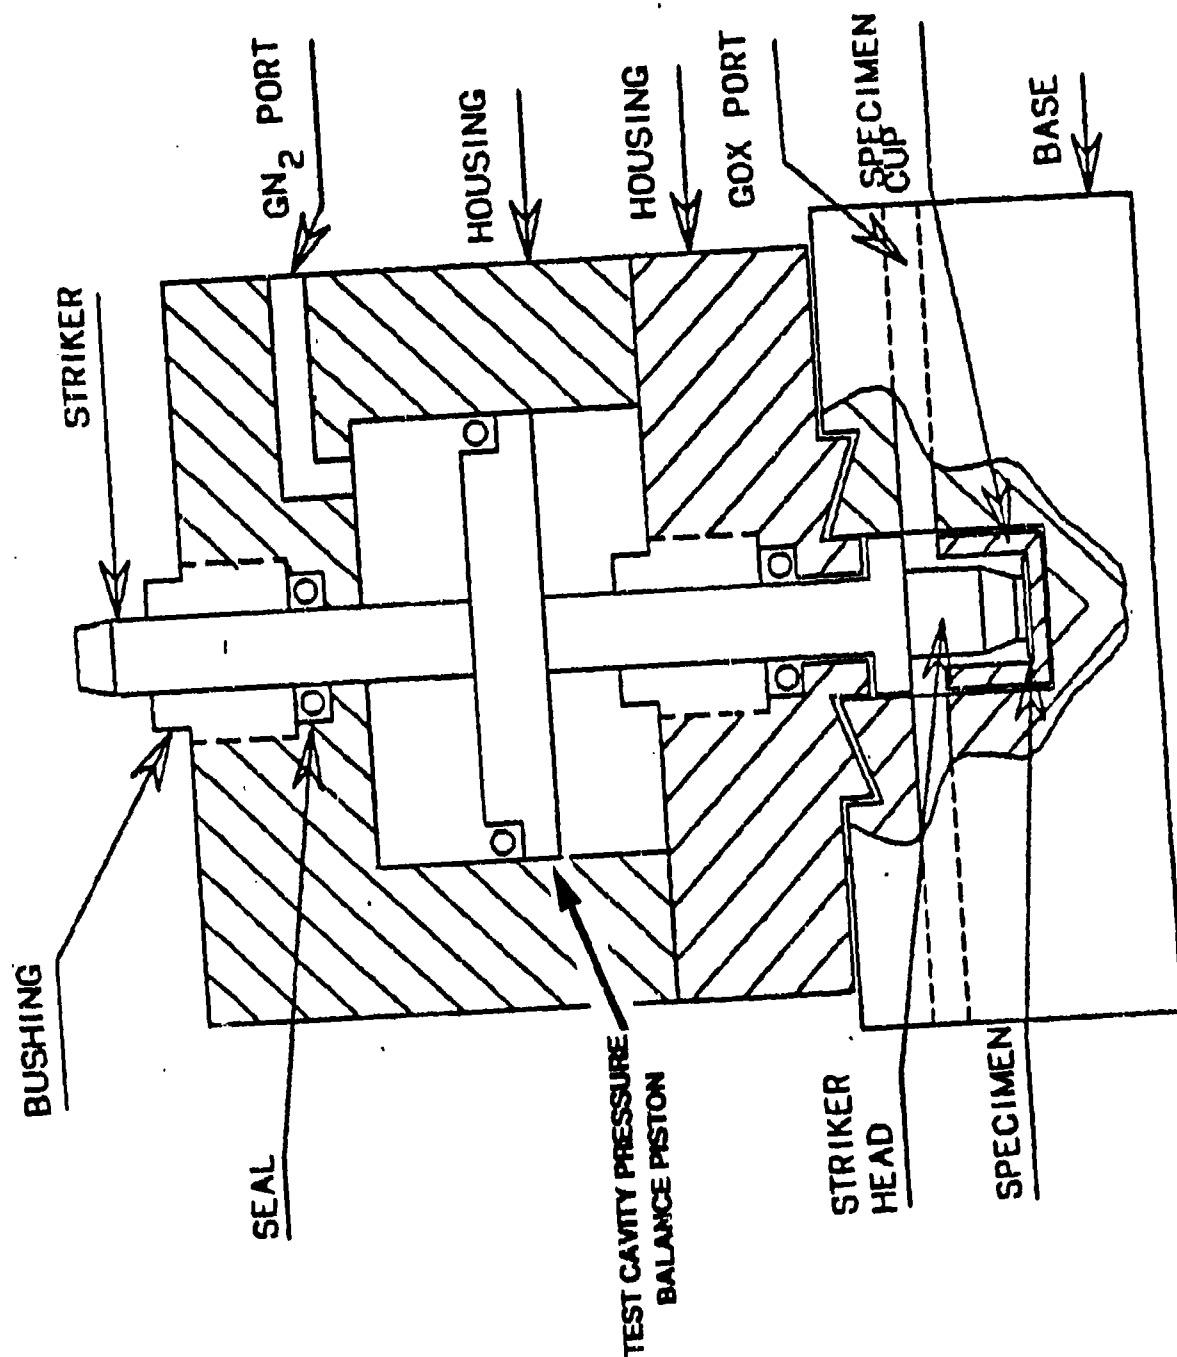
Figure 10

High Pressure O₂ Impact Tester Housing

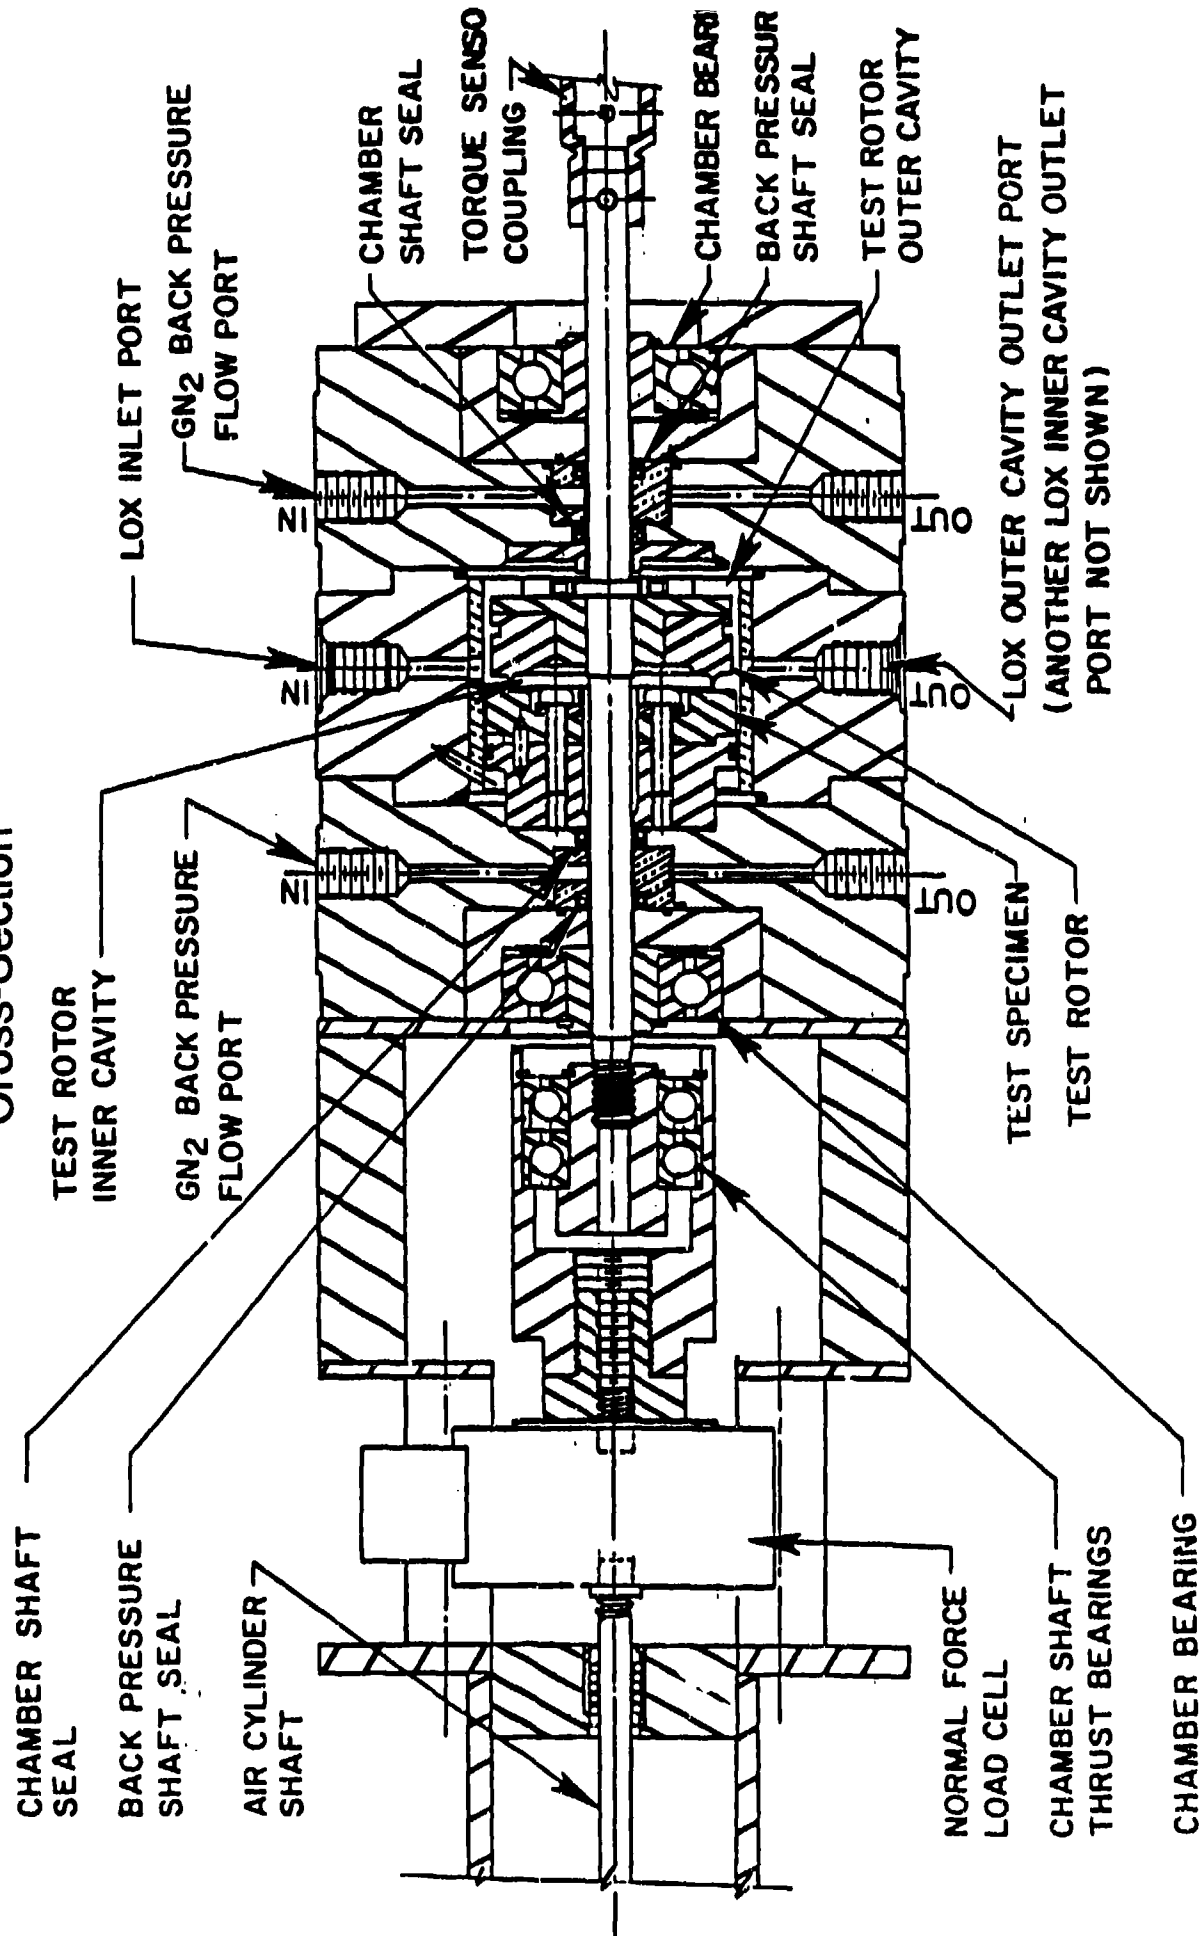
Figure 12

Low Speed Friction and Wear Tester Cross-Section

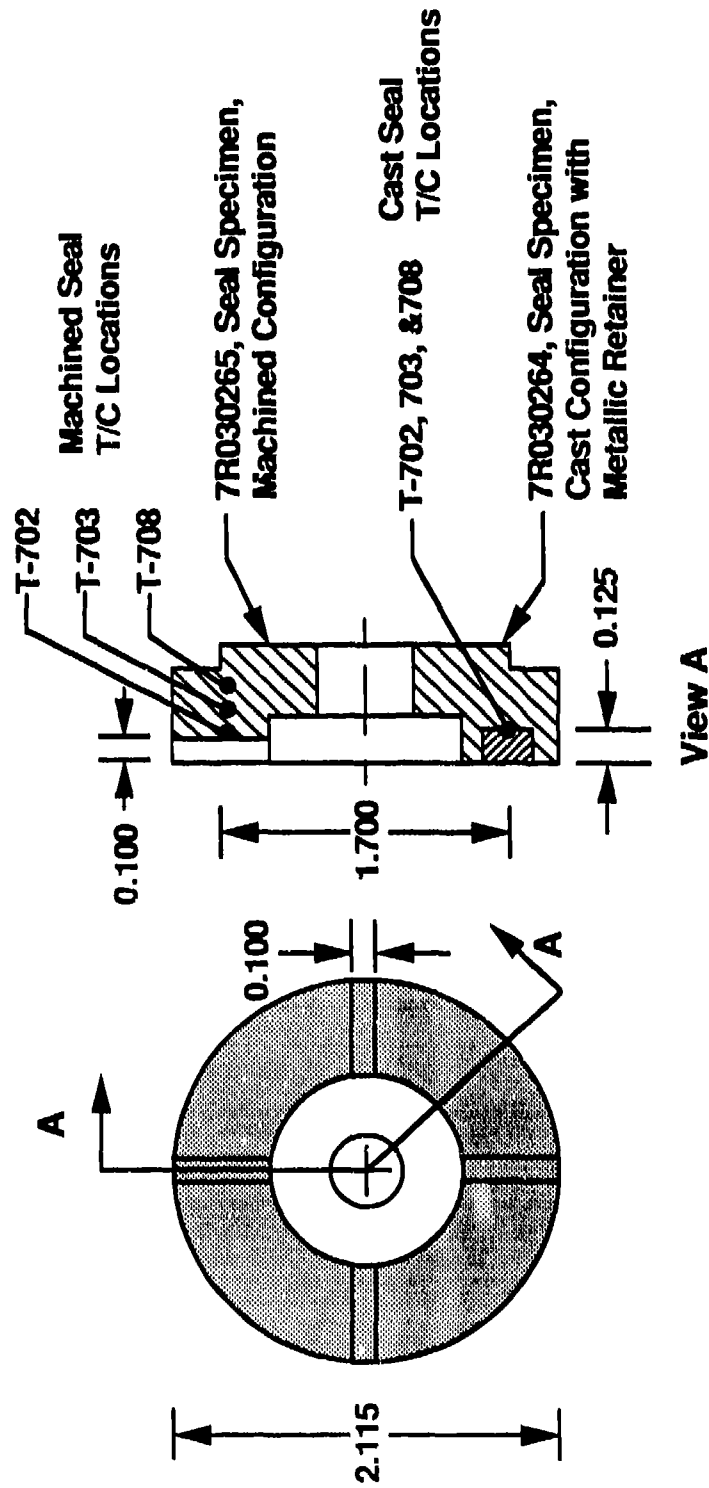
Figure 14

Low Speed Test Soft Seal Specimen Configuration

This manufacturing technique was very desirable, in that the seal could be poured right into a turbopump housing. No mechanical fasteners or restraint systems are required to support or locate the seal. An example of this technique was demonstrated in Orbital Transfer Rocket Engine Technology Program - Task B.2. Using a dove-tailed groove, Hexcel 3125 was centrifugally cast into the inlet flange of the High Velocity Ratio Diffusing Crossover tester to produce the inducer tip seal, as shown in Figure 16. A similar approach was used to pour the interstage seal on the inner diameter of the crossover housing. Both seals performed well but were damaged when a tester ball bearing failed. The seals were sacrificed as protection for the more expensive crossover and inducer components. With only minor repair these very expensive components could be reused. The seals could also be repaired by removing the remaining material and casting new material back into the dove-tailed groove.

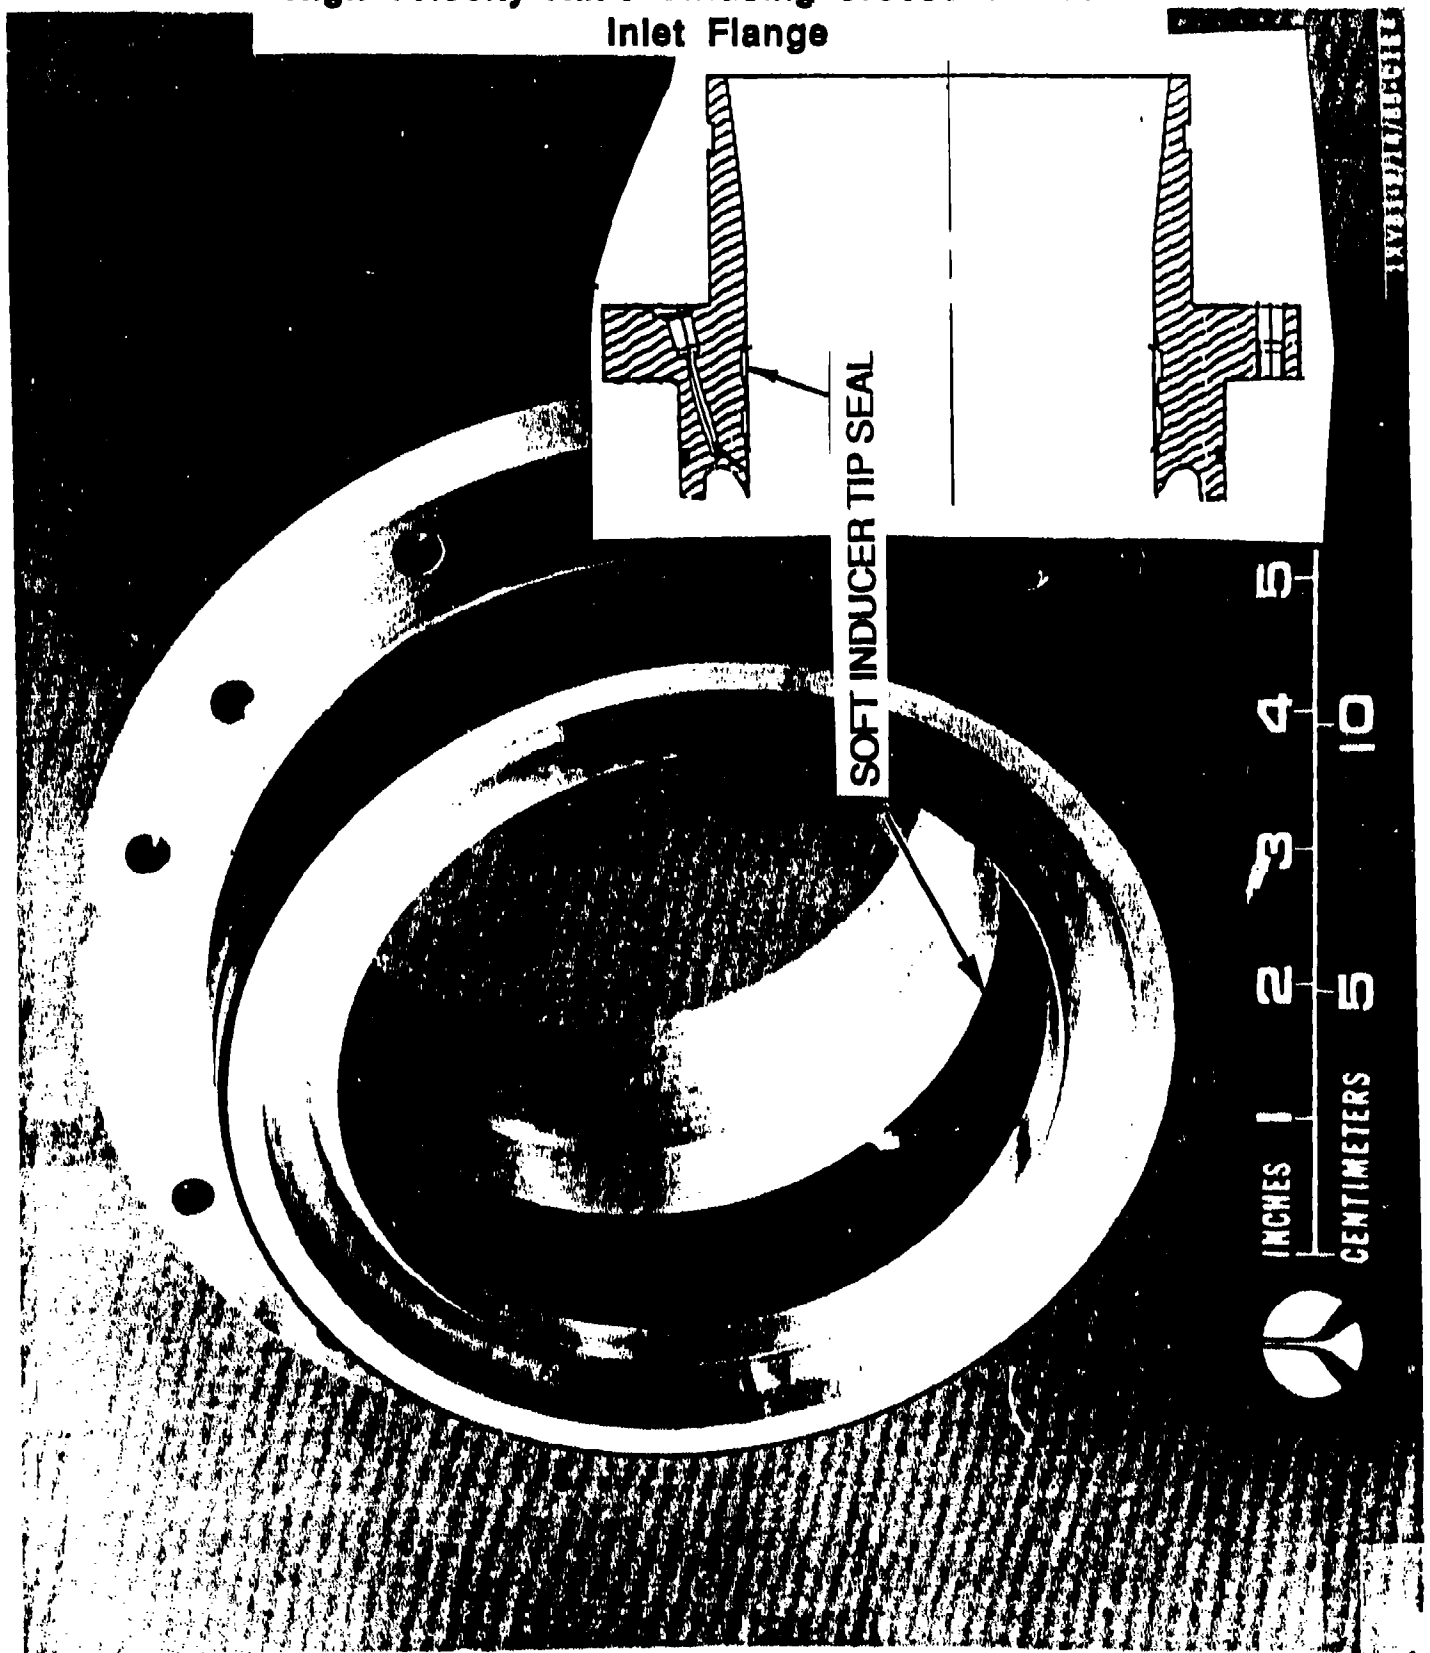
Figure 16

High Velocity Ratio Diffusing Crossover Tester Inlet Flange

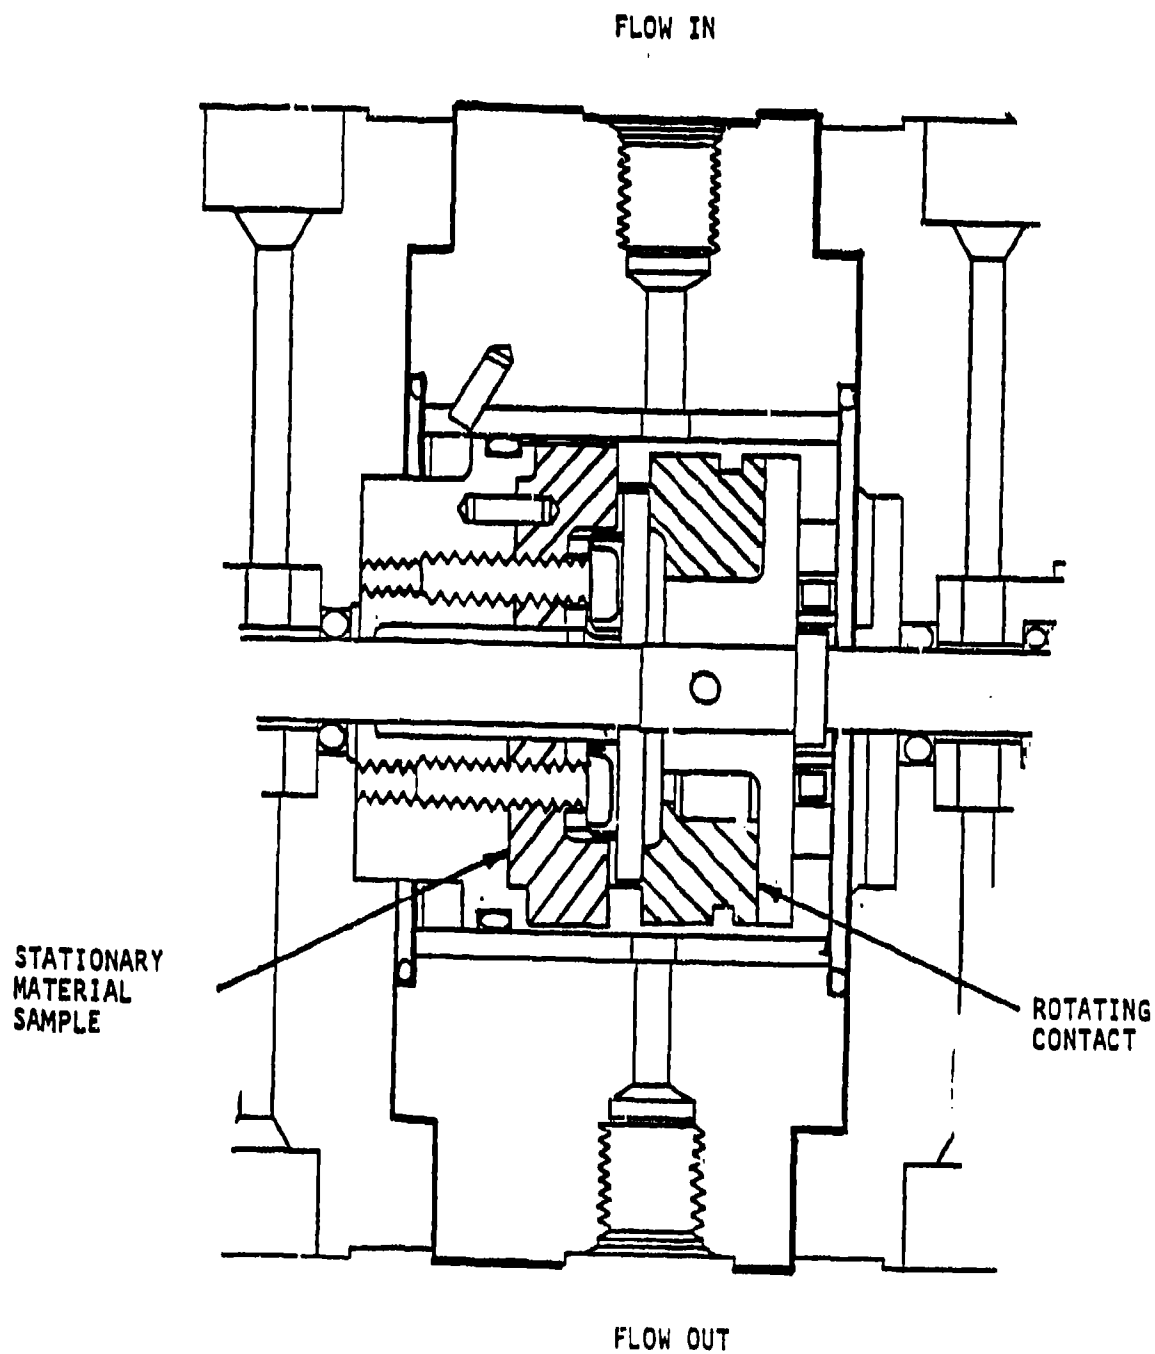
Figure 17

Low Speed Tester Internal Flow Paths

The test fluid entered the test chamber of the low speed friction and wear tester through an inlet port on the top of the tester and drained through two ports on the bottom of the tester. The fluid flow path was complicated by the axial contact of the rotor and the seal specimen. Flow passed around the contacting specimens to the test chamber outlet, as well as between the seal and the seal retainer, as seen in Figure 17. Several holes and channel patterns, as seen previously in Figure 15, were machined into the seal specimens to allow the test fluid flow all around the specimen to obtain the maximum cooling. In a turbopump seal, the flow is basically axial with a strong tangential component. This tester could not provide the identical flow distribution and rubbing condition that a typical seal would see, so the additional passages were included to maintain sufficient coolant.

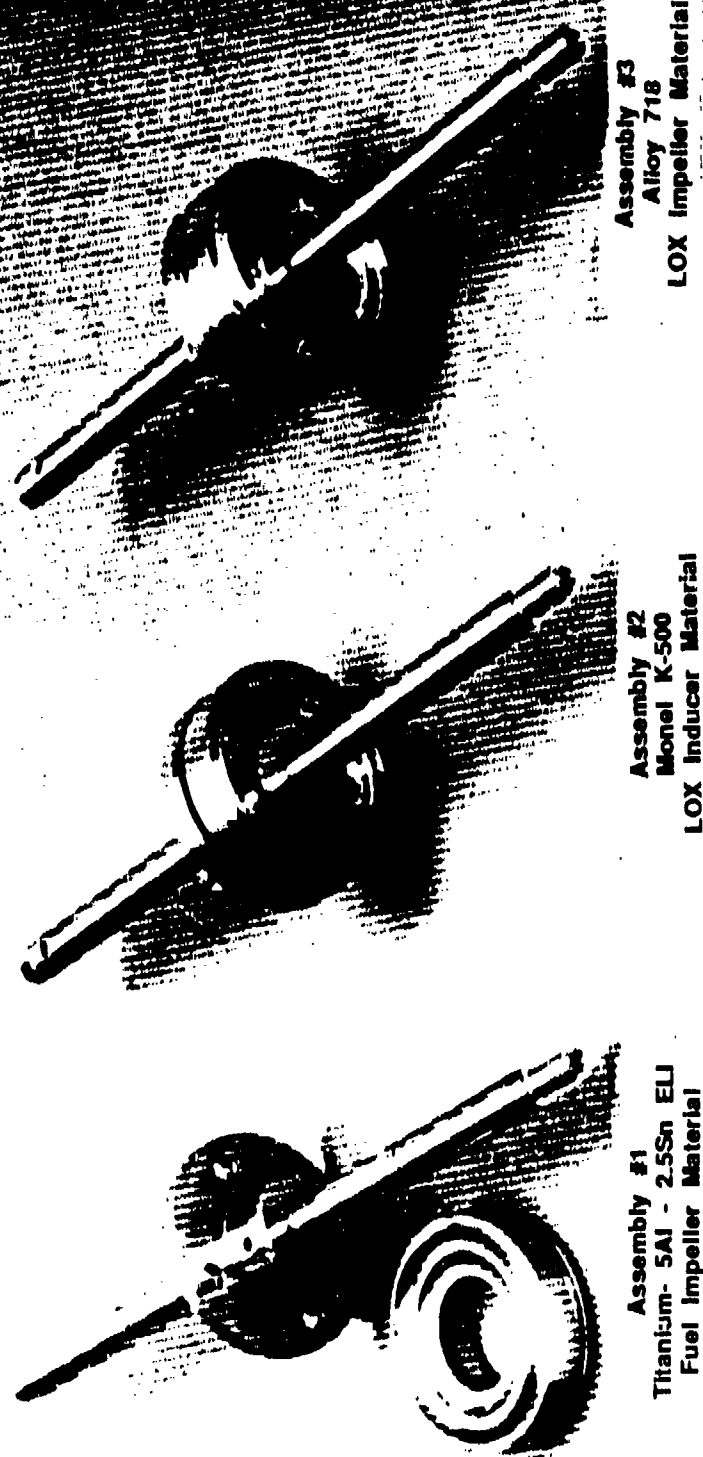
Figure 19

Low Speed Friction and Wear Tester Rotor Specimens

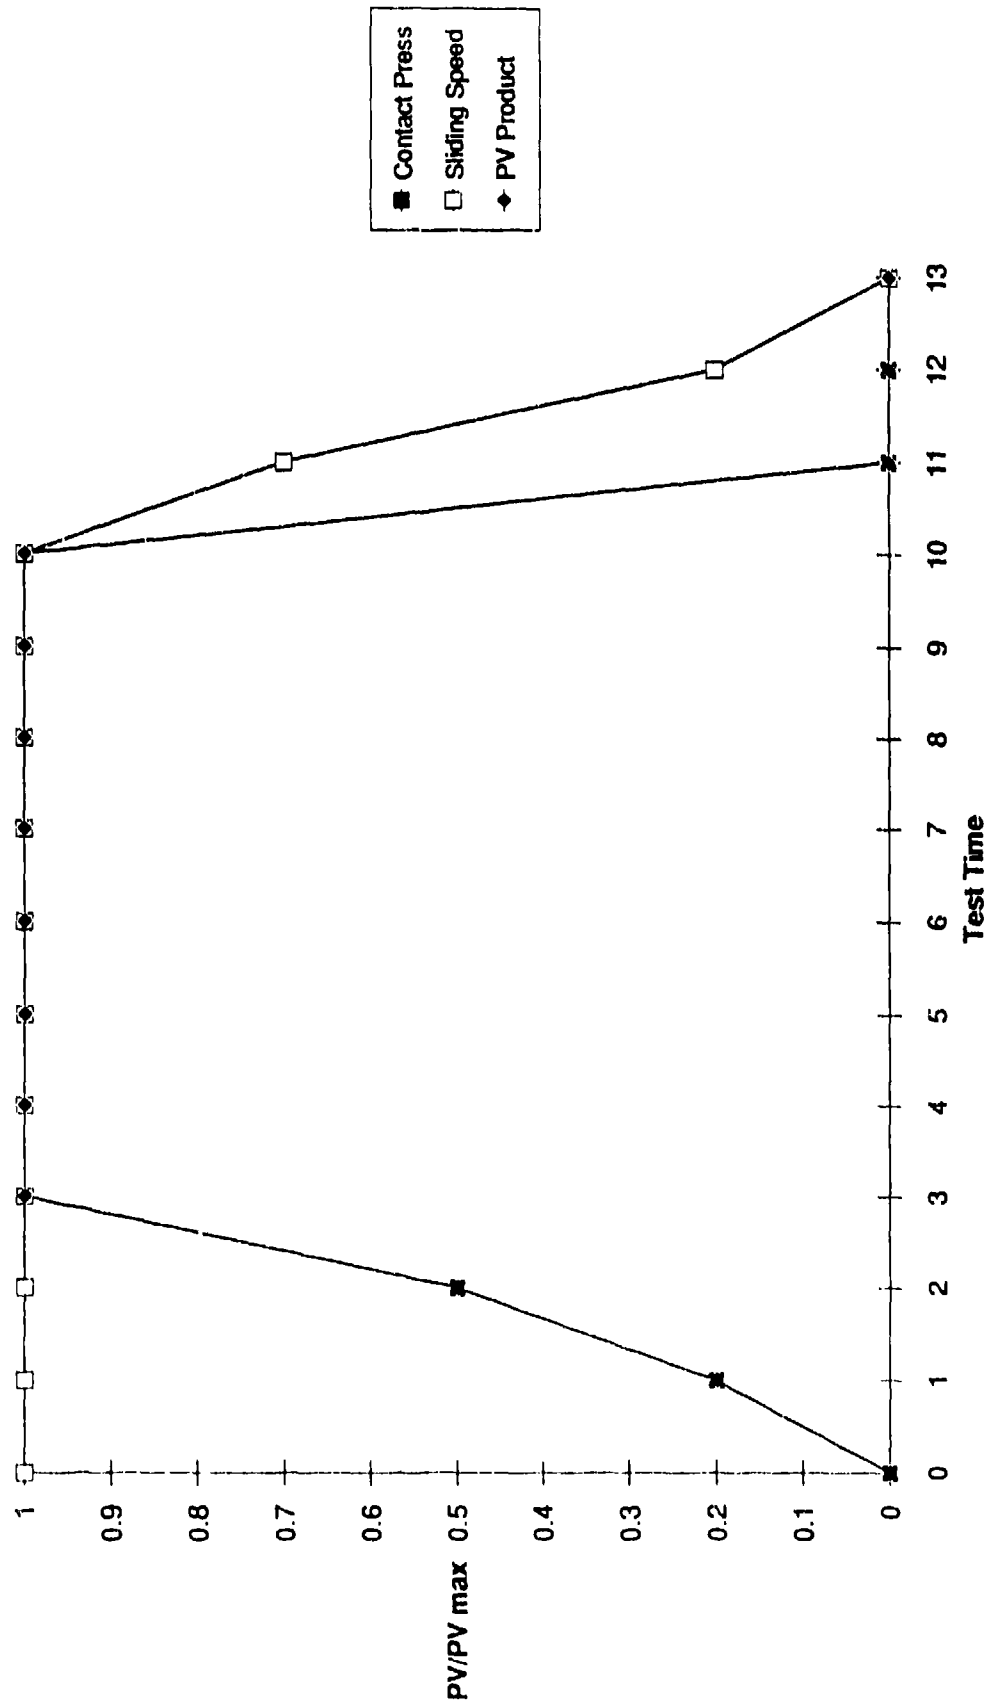
Figure 21

Typical Running Friction Test Profile

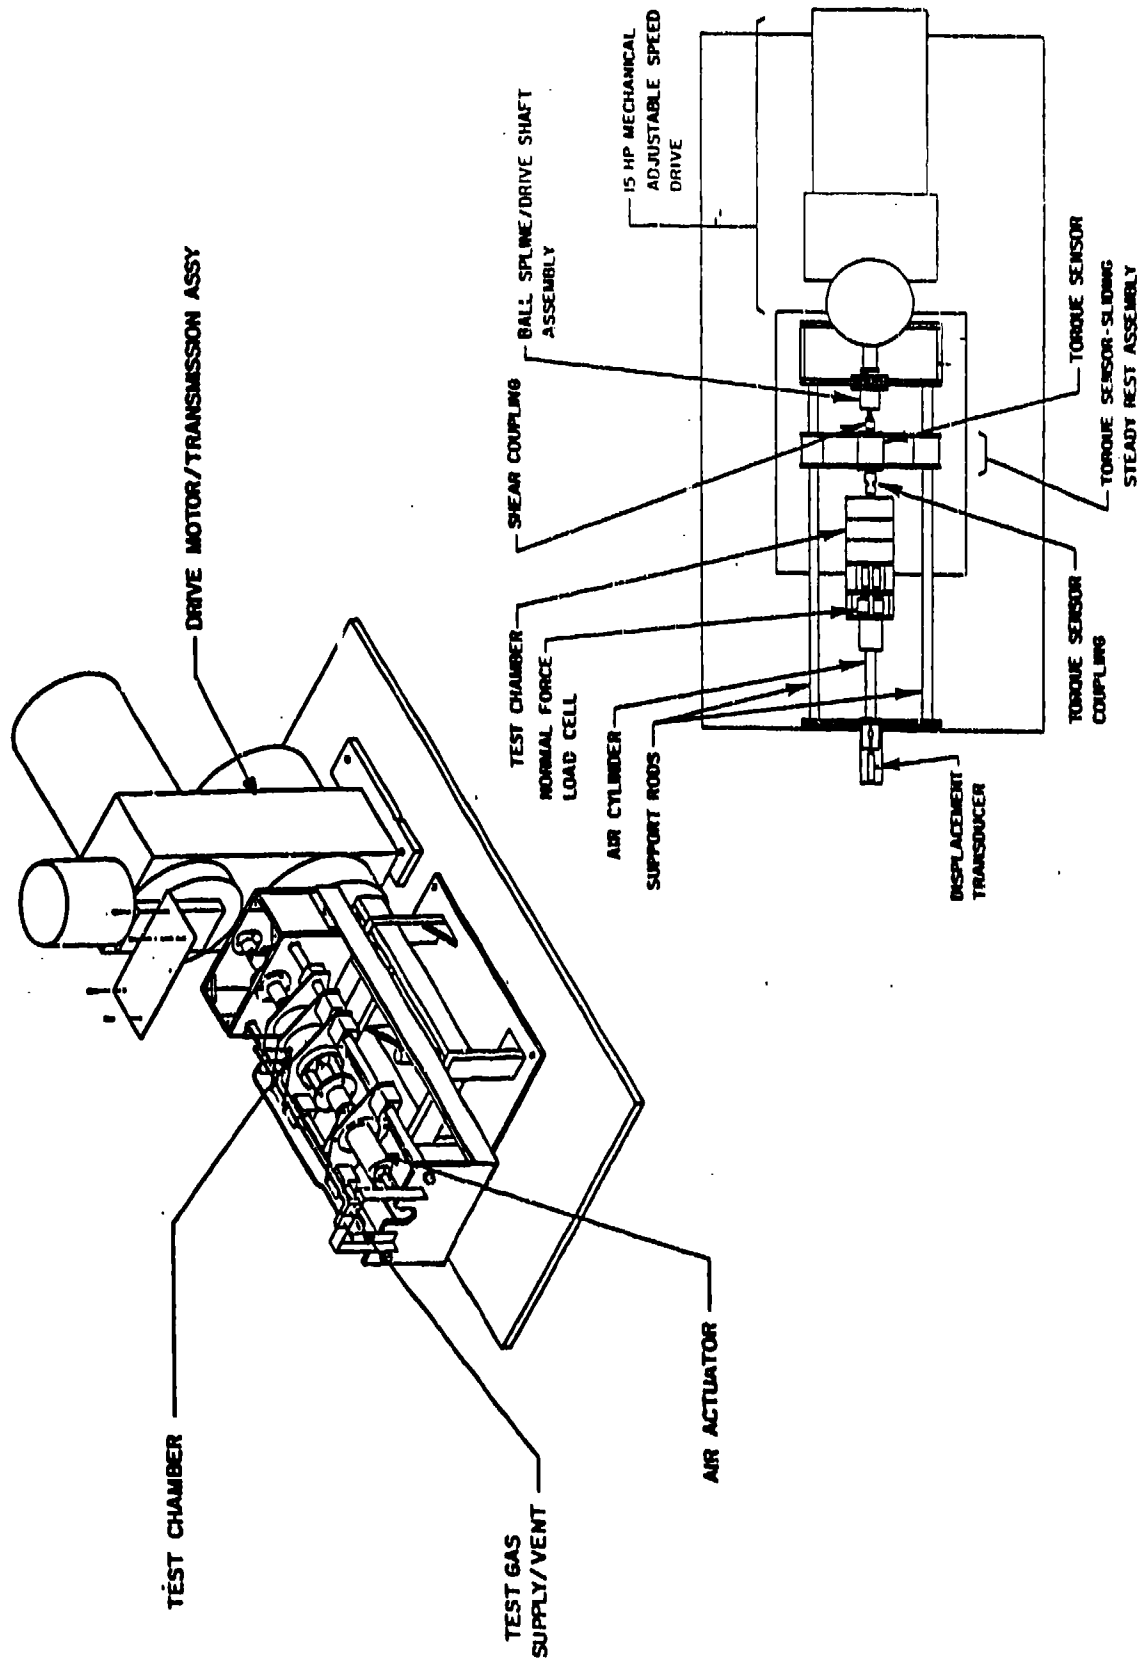
Figure 22

Low Speed Friction and Wear Tester

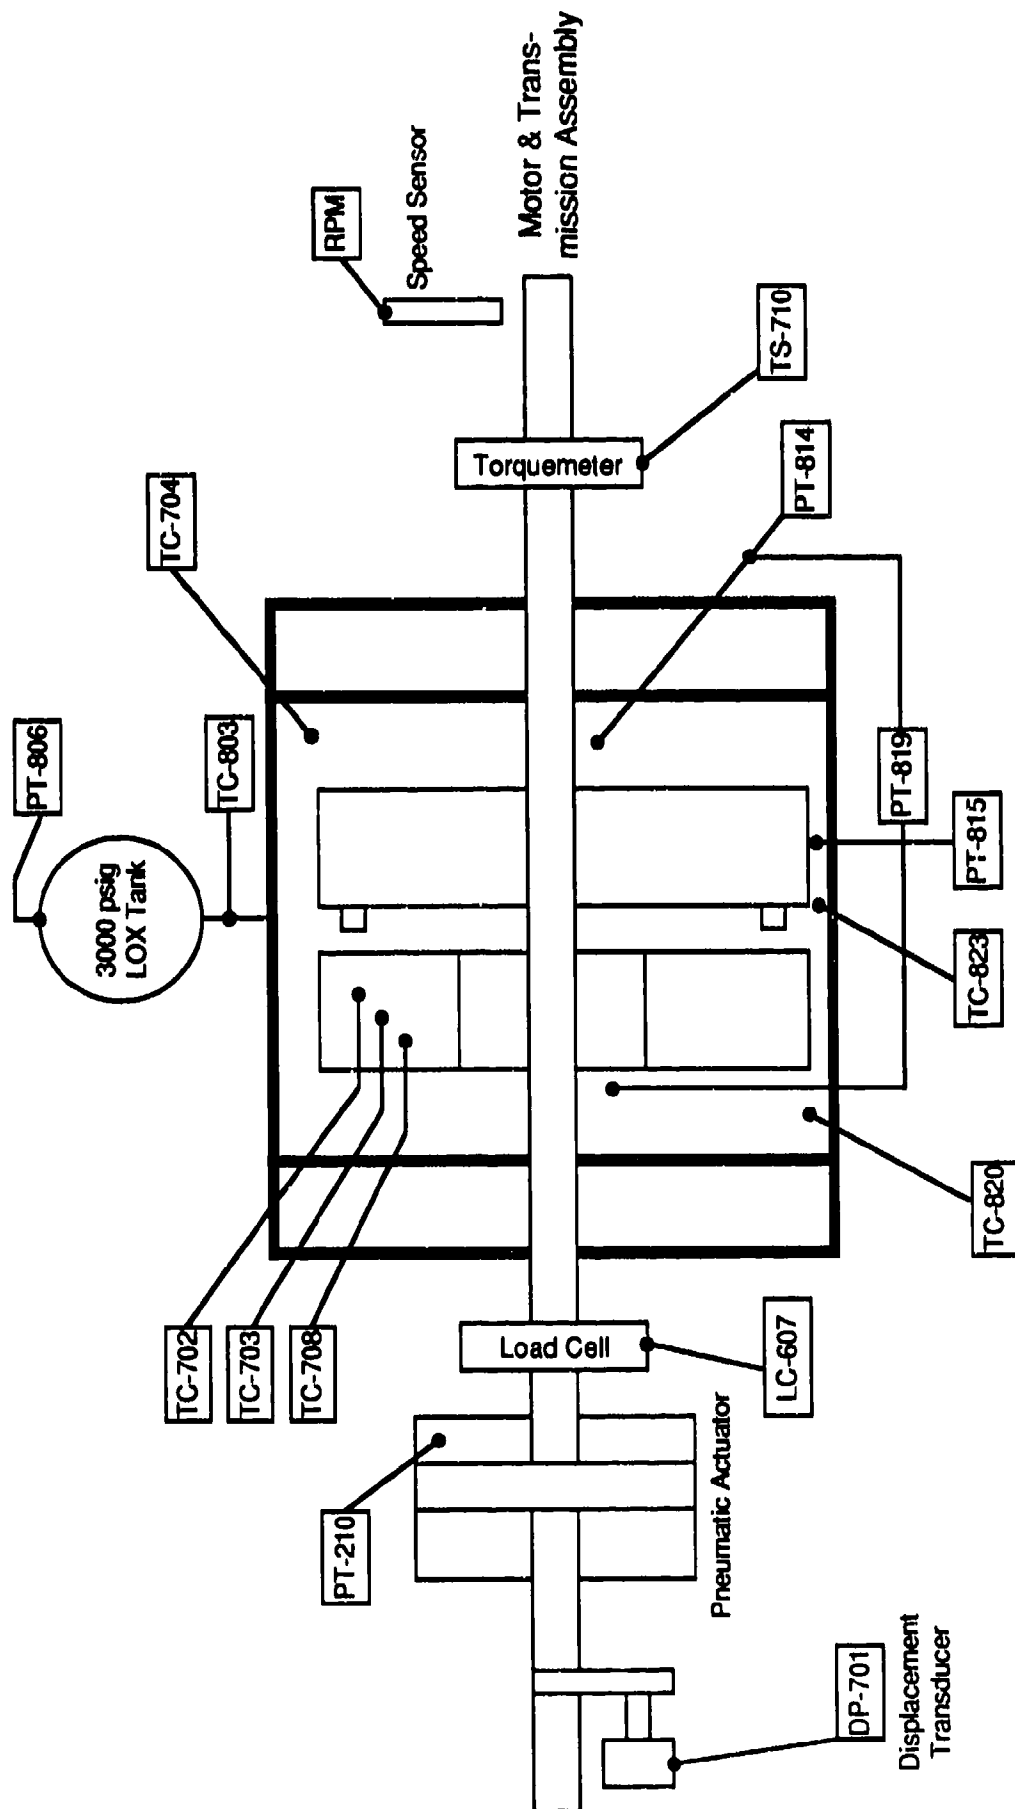
Figure 25

Low Speed Friction and Wear Tester Instrumentation Schematic

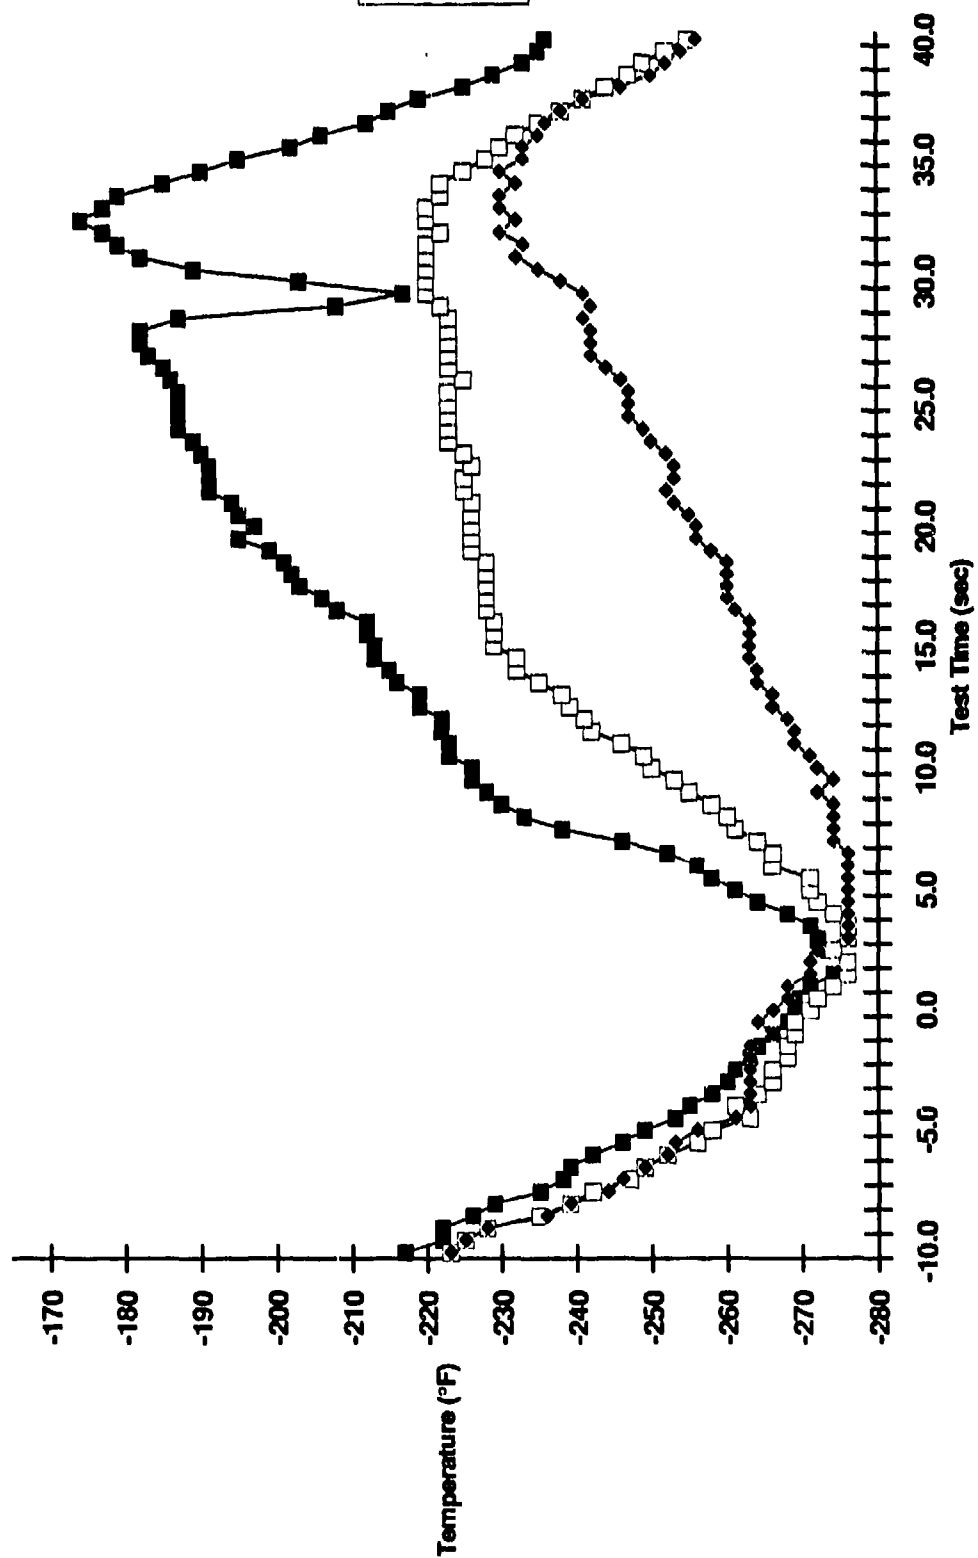
Figure 26

Test WS30F: Temperature Distribution in Seal
